TESTING OF RECIPROCATING SEALS FOR APPLICATION IN A STIRLING CYCLE ENGINE

J. F. Curulla and T. L. Beck
Boeing Commercial Airplane Company

FEBRUARY 1980

Prepared for
NATIONAL AERONAUTICS AND SPACE ADMINISTRATION
Lewis Research Center
Under Contract NAS 3-20612

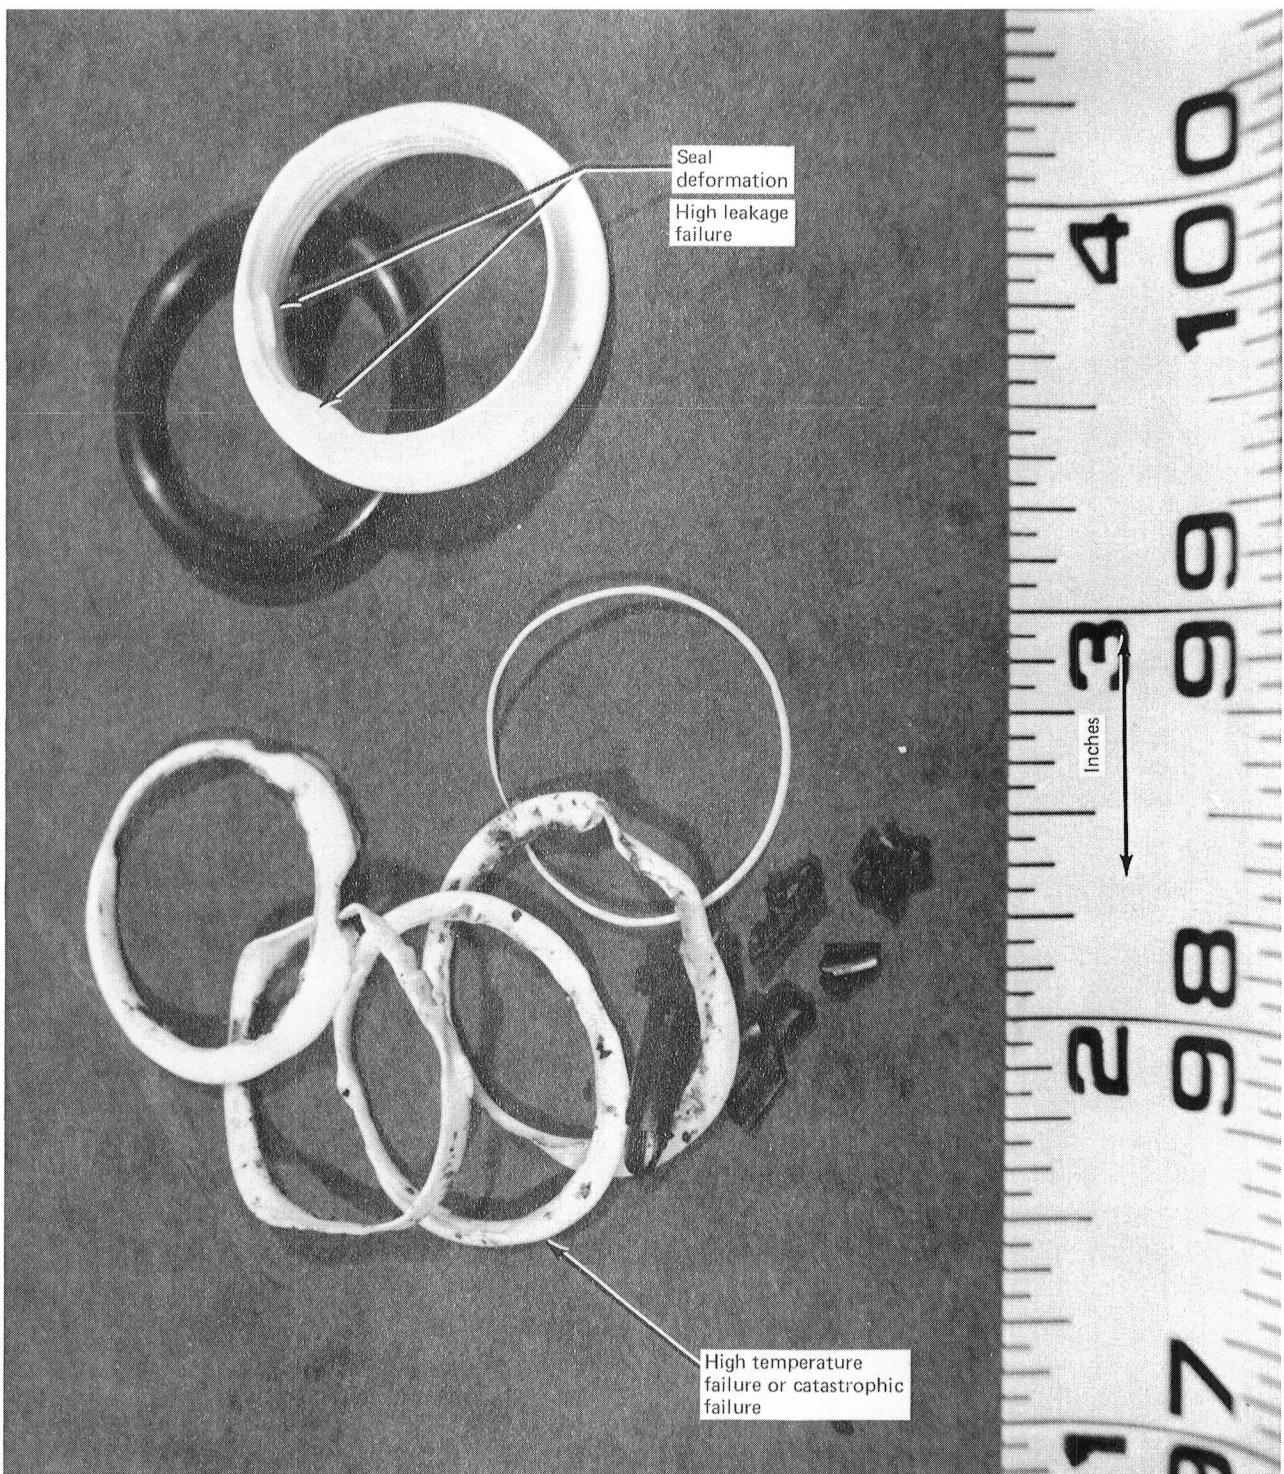
Figure 16. — Boeing Footseal Failures

Eight sets of Boeing Footseals were evaluated with four of the sets failing due to high temperature deformation without any leakage information being obtained. The seals were tested at the conditions of 1.22×10^7 PA (1750 psig) and 7.19 m/sec peak (3000 rpm), and gave leakage rates of 0.0154 and 0.0104 cc/sec for set #2 seals #1 and #2, respectively, which was five to seven times the leakage criteria goal of 0.002 cc/sec. All other leakage data obtained from the Boeing Footseal was at a helium pressure of 5.28×10^6 PA (750 psig) and a test rod velocity of 1.03 m/sec peak (430 rpm). Three runs were performed at these conditions on sets #1, #3, and #4 with set #3 providing the best leakage information. The lowest leakage rates obtained during this run were 0.0043 and 0.002 cc/sec for seal #1 at 9 and 9.5 minutes into the test. However, shortly after this time, the leakage rate jumped to .049 cc/sec on seal #2 and the test was terminated. Testing of sets #1 and #4 revealed similar leakage values ranging from 0.0104 to 0.68 cc/sec.

Of these five failure types, specific seal configurations were of one type of failure mode more than another. The NASA Chevron seal, because of its high frictional characteristics, tended to cause more drive linkage failures than the other seal designs. The Bell seal also had one failure of this type. All seals displayed high leakage and overtemperature failures. Catastrophic leakage failures were observed with the Boeing Footseal, Bell seal, and Quad seal all showing rapid manometer level rises. Figures 16 through 19 are photos of the types of failure modes for the Boeing Footseal, NASA Chevron Polyimide seal, Bell seal, and Quad seal. These photos show the most dramatic failure occurrences of each seal. Figure 20 shows the high frictional abrasion failure mode of the dynamic test rod.

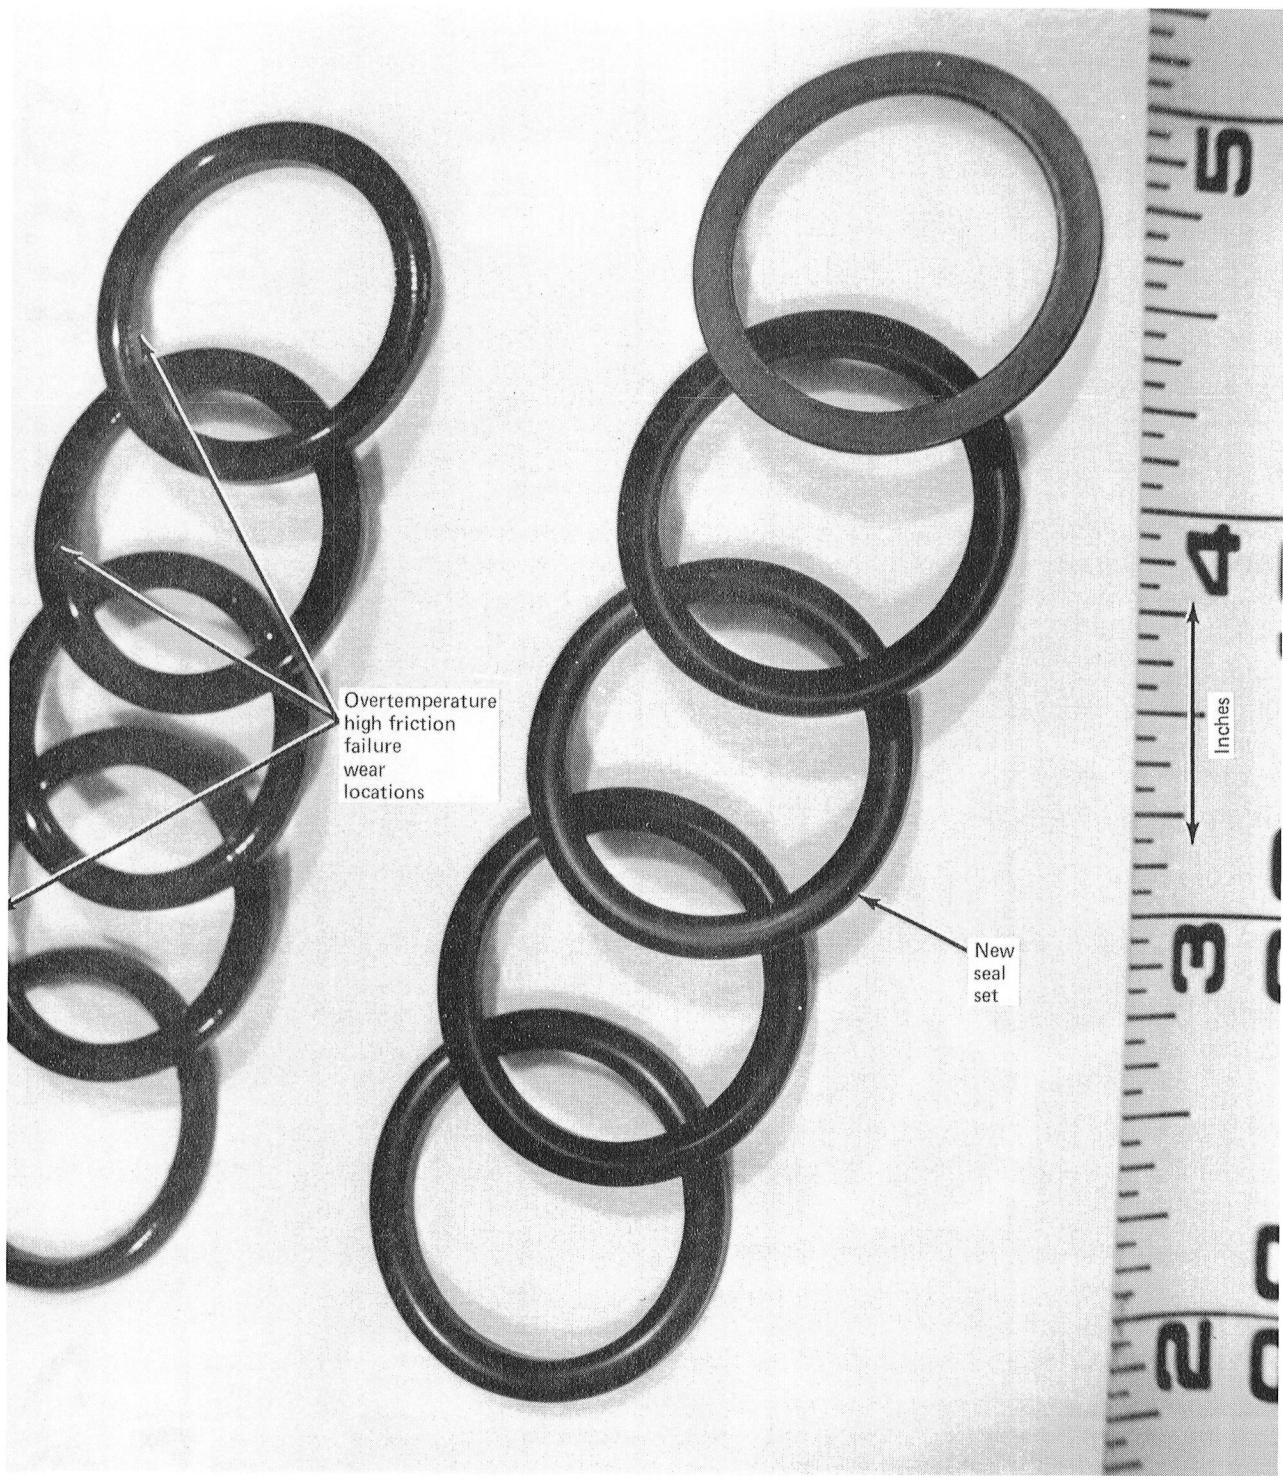
Figure 17. – NASA Chevron Seal Failure

Three sets of NASA Chevron seals were evaluated, with two failures resulting in breakdown of the seal. The NASA Chevron polyimide five-piece leg seal showed improved leakage

results over those of the Boeing Footseal. However, because of the high frictional forces produced between the seals and test rod interface, excessive vibrations were produced that prevented varidrive operation above 2.16 m/sec peak (900 rpm) with 1.22×10^7 PA (1750 psig) helium gas pressure. Realignment of the test setup did not alleviate this condition. Leakage rates ranged from 0.0036 to 0.0146 cc/sec for seal set #2, with a failure leakage rate of 0.2629 cc/sec. Testing on this seal was discontinued in favor of the Bell seal.

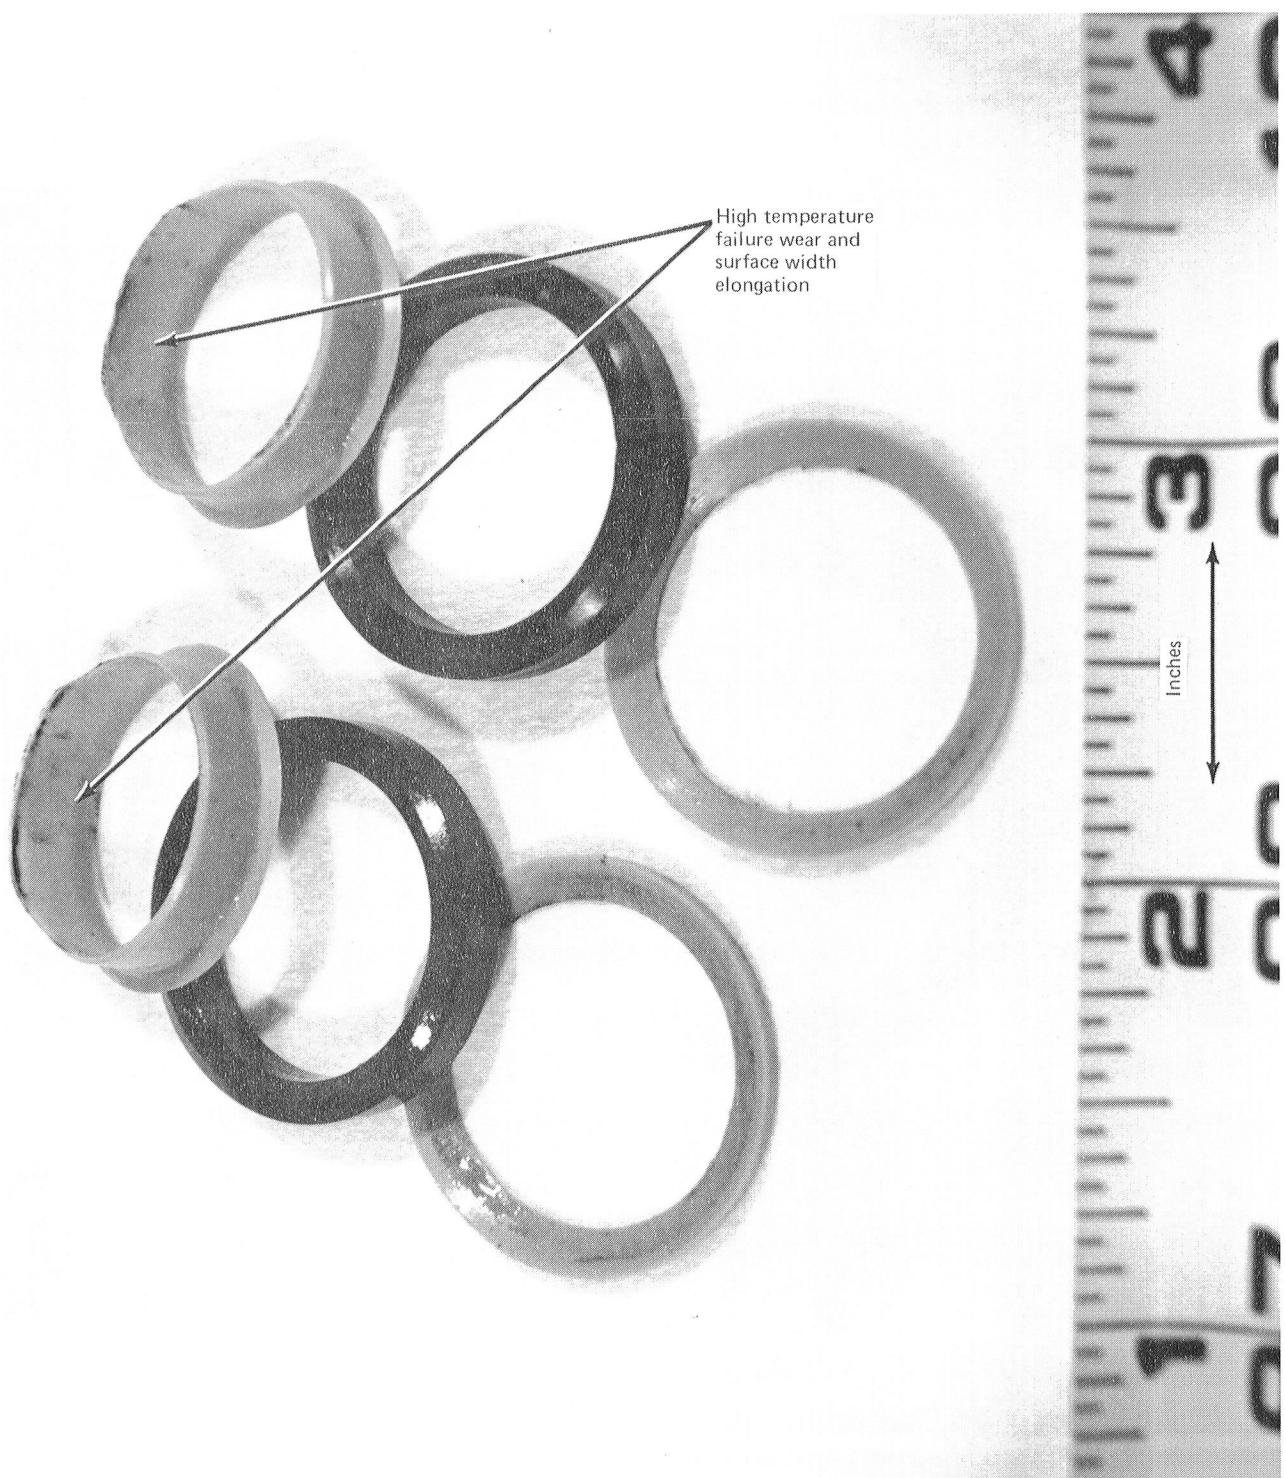
Figure 18. — Bell Seal Failure

Four sets of Bell seals were evaluated during this program. The majority of leakage rates obtained for seal set #1 had values between 0.01 and 0.04 cc/sec. A total of five test readings were taken of rates below 0.005 cc/sec. Of course, three were at or below the 0.002 cc/sec leakage goal. A minimum rate of 0.0010 cc/sec (fig. 31, Appendix B) was obtained from seal #1 after 84 minutes of testing at conditions of 1.22×10^7 PA (1750 psig) and 2.16 m/sec peak (900 rpm). This rate and the post test value 0.0012 cc/sec at 54.48 hours into the test were the only values obtained below 0.002 cc/sec for the entire seal set. The second set of Bell seals indicated leakage rates below 0.03 cc/sec. This test was initiated at 2.16 m/sec peak (900 rpm) and after 4.62 hours was accelerated to 7.19 m/sec peak (3000 rpm). As the peak rod speed was obtained, the leakage rate increased dramatically to 0.78 cc/sec. This was the largest rate obtained by this seal set. Bell seal set #3 provided leakage rates from .0033 to .0100 cc/sec at test conditions of 5.28×10^6 PA (750 psig) and 2.09 m/sec peak (1750 rpm). The Bell seal set #4 was the final set run with pressure at 5.28×10^6 PA (750 psig), and the rod speed was step-incremented between 1.03 m/sec peak and 4.79 m/sec peak (430 and 2000 rpm) to allow seal temperatures to remain near 408 K (275°F). The most promising leakage results were obtained from this seal set with the majority of leakage data for both seals below 0.02 cc/sec. Also, a large set of data was obtained below the 0.002 cc/sec leakage goal with some values as low as 0.001 cc/sec over 5-minute time increments.

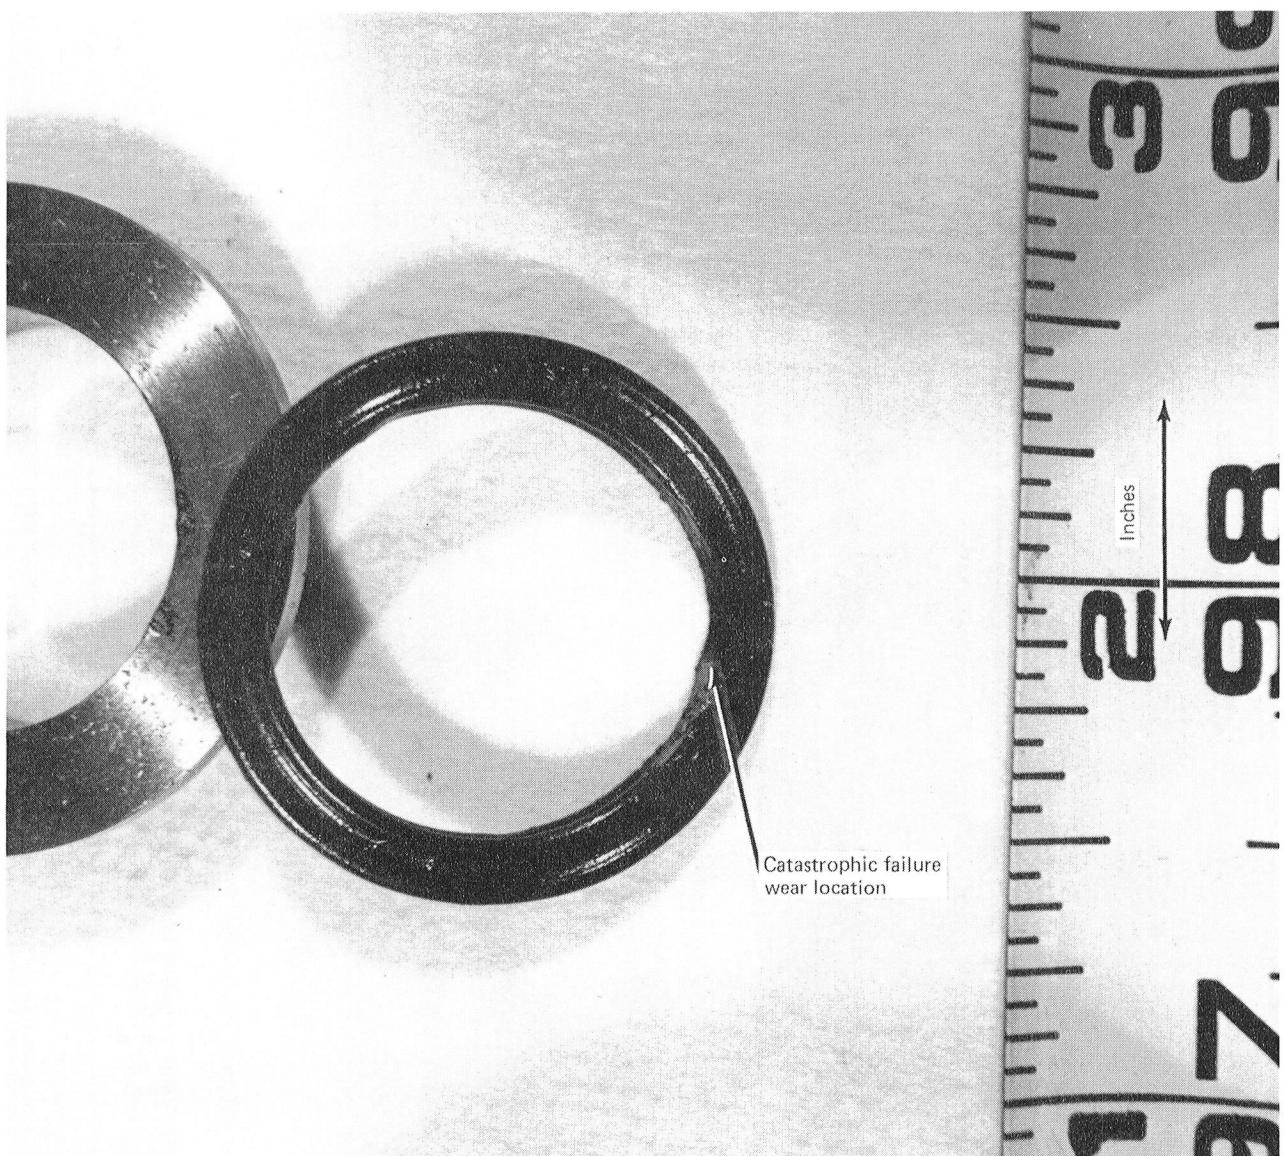
Figure 19. — Quad Seal Failure

Four sets of Quad seals were evaluated. The first set was run at 1.22×10^7 PA (1750 psig) and 7.19 m/sec peak (3000 rpm). The final leakage rates were 0.60 and 0.63 cc/sec for seals #1 and #2 and failure occurred after two minutes of testing. The second set was run at 5.28×10^6 PA (750 psig) and rod speed was increased from 1.03 m/sec peak (430 rpm) to 2.09 m/sec peak (1750 rpm). Leakage rates obtained from this set were significantly better than those of the previous run. Most of leakage data obtained were below 0.05 cc/sec, with one value for seal #2 as low as 0.0016 cc/sec for one minute. Seal set #3 was run with a helium supply pressure of 5.28×10^6 PA (750 psig) and an initial test rod velocity of 1.03 m/sec peak (430 rpm) with a velocity buildup to 4.79 m/sec peak (2000 rpm). Leakage rates for this seal set were as high as 0.01 cc/sec. For seal set #2, some leakage rates obtained were as low as 0.0011 cc/sec. Seal set #4 was exposed to a series of test runs alternating in steps between 1.03 m/sec peak (430 rpm) and 4.79 m/sec peak (2000 rpm). Most of the leakage results for this seal set were below 0.03 cc/sec.

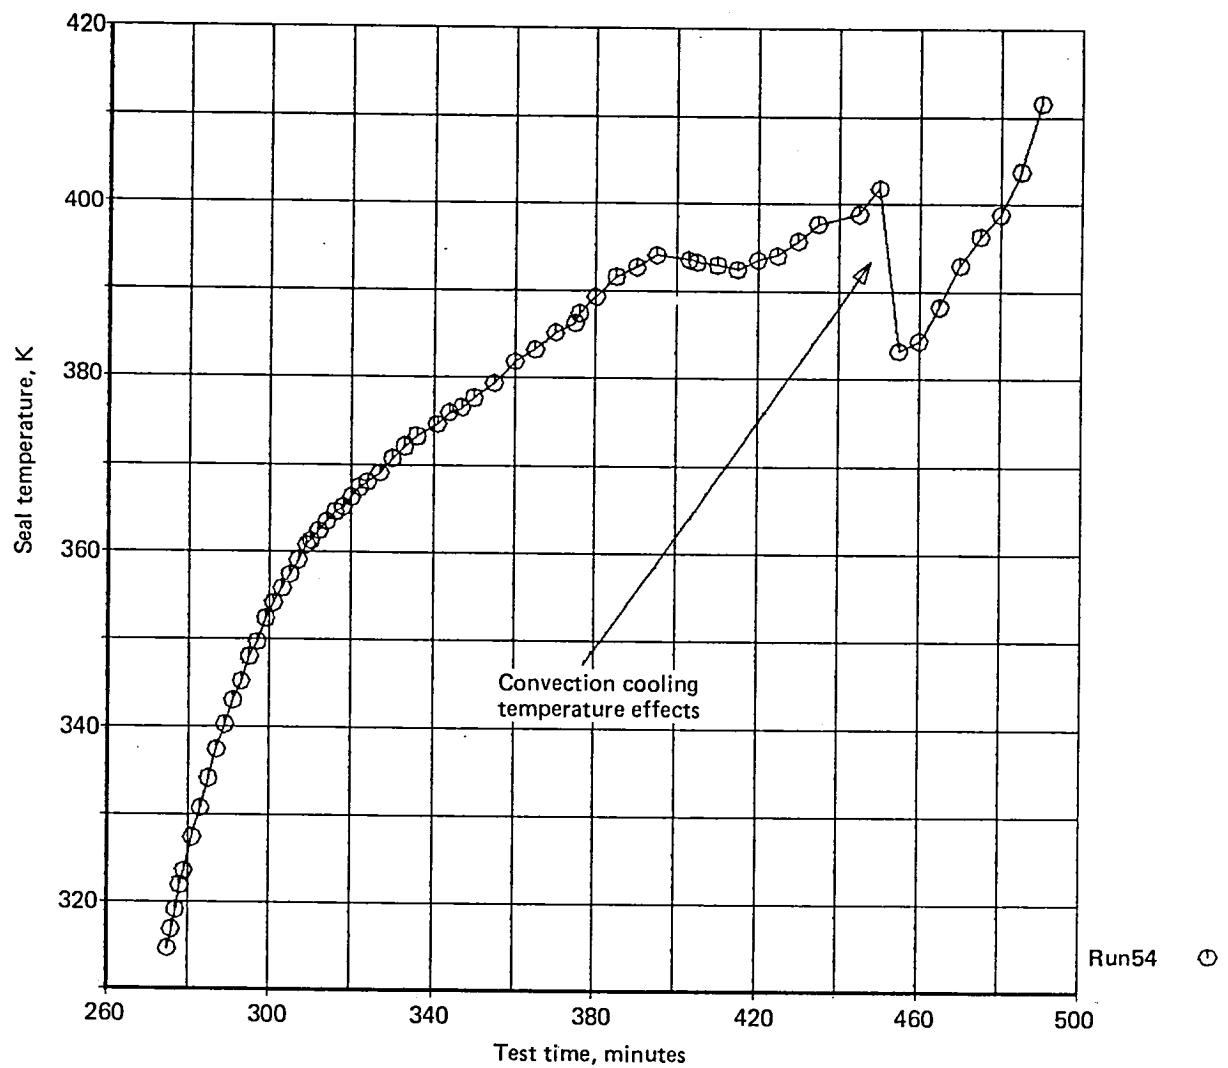
Figure 21. — Convection Cooling Temperature Effects,
Quad Seal Configuration

Large temperature rises at the test seals (see Appendix B for temperature data for each seal set) were caused from the high frictional loading forces generated between the test seals and dynamic test rod. Three methods were used to control the rate of temperature increase with test time:

In any future investigation of seals in a Stirling cycle environment, it is concluded that some method of shaft and/or seal cooling is required. A recommended method of cooling the seal environment is to direct a pressurized air or oil mist at the test rod at the seal interface. Cooling fluid jackets should be provided in the seal retention housing as close to the test seal as possible to carry away additional heat. Additional cooling can be provided by using forced convection on the inside diameter of the test rod. These cooling methods will improve the endurance life of the seal but will not necessarily decrease the high leakage rates of the various seals.
